GOFFS FALLS DAM

NH 00292

PHASE I INSPECTION REPORT NATIONAL DAM INSPECTION PROGRAM

DECEMBER 1980

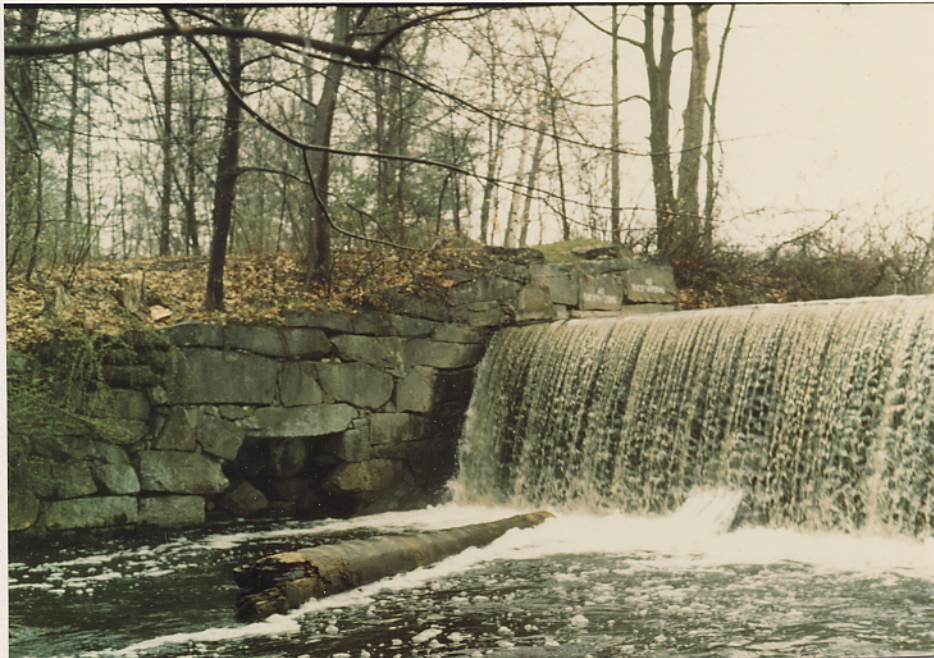
The upstream portion of the dry, split stone, masonry structure is in good condition. However, the downstream portion of this structure exhibits a void approximately 5 feet square. A sink hole was observed on the right bank immediately above this void. This hole was approximately 2 to 3 feet in diameter at the surface and is the result of fine material being washed out through the void in the wall below.

1. Right Abutment and End Wall - Note Undermined Section
Downstream of Spillway

The Goffs Fall Dam is in POOR condition at the present time. The abandoned sluiceway should be reconstructed in order to preclude failure of the left bank and to provide a means to lower the pond level in the event of an emergency. The void in the right end wall should be repaired.

It is recommended that the services of a qualified registered professional engineer be retained to evaluate the condition of the abandoned sluiceway and the undermined right end wall and sinkhole. The engineer should prepare recommendations and complete plans for rehabilitation of these structures. The owner should implement the findings of this evaluation.

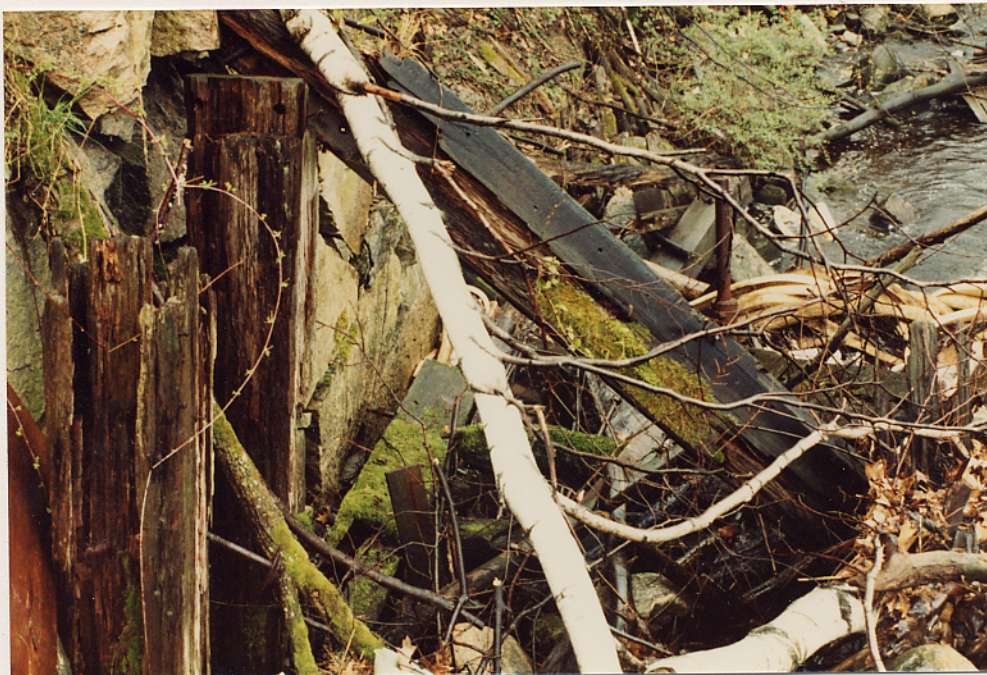
This sluiceway which is located immediately to the left of the spillway has been abandoned and is in deteriorated condition. The opening of this structure is partially filled with earth, rotted timbers, the remains of timber sluice gate stems, and a broken metal gate. Small hand stones have been placed at the interface with the sluiceway in order to divert the flow over spillway. These stones are in the range of 6 to 8 inches in height with considerable voids throughout its length.

This abandoned sluiceway is in poor condition.

2. Sluiceway at Left Abutment - Note Rubble and Debris
Blocking Channel

- a) The abandoned sluiceway is in need of rehabilitation as its condition threatens the stability of the left abutment. If the sluiceway cannot provide adequate drawdown capability, a low level outlet should be considered.
- b) The right end wall has a large void at the base.
- c) The spillway and downstream channel need clearing of debris.
- d) There is no means available to lower the impoundment in the event of an emergency.

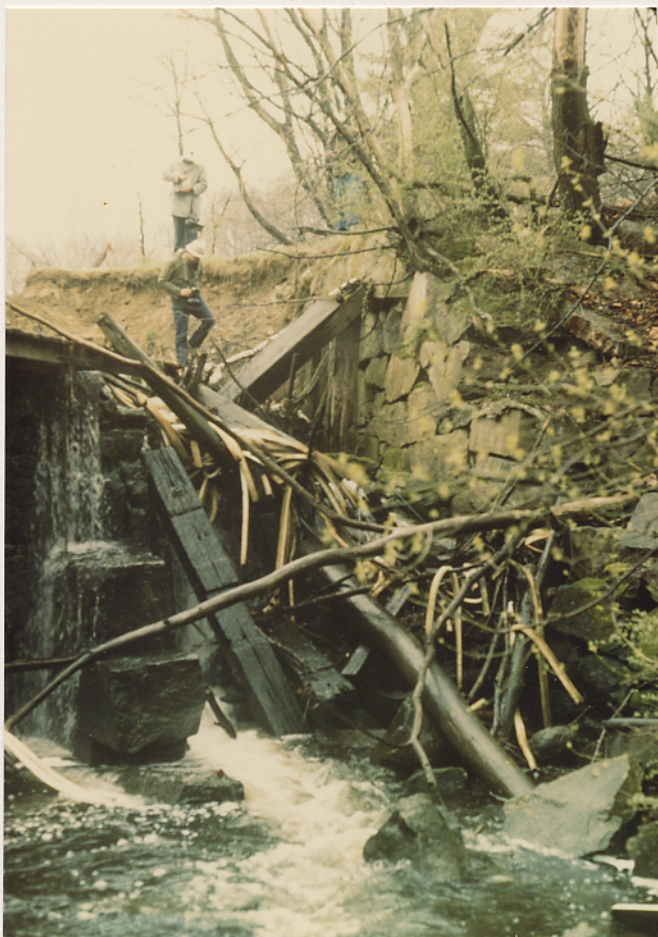
The dry, split stone, masonry wall is in fair condition with the exception of the displacement of stone at the downstream end of the abandoned sluiceway. The upstream extension and the return into the left bank are in good condition. Visual observations also revealed the upstream portion of this wall lacks continuity. Large trees are flourishing at this location.

3. Upstream View of Sluiceway - Note
Missing Portion of Left Endwall

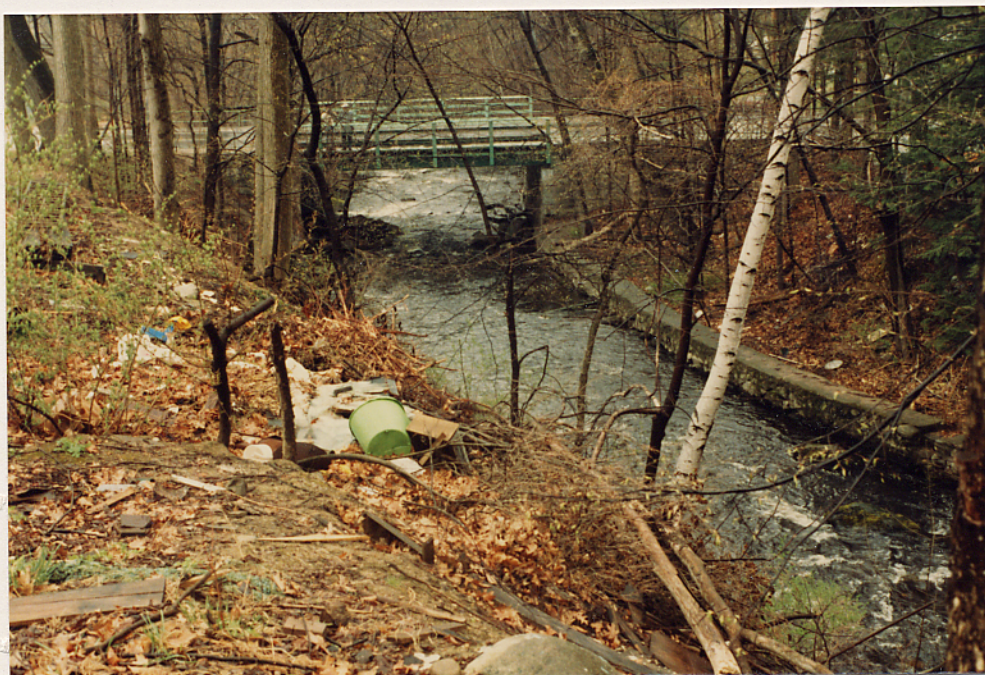
The downstream channel is the Cohas Brook channel. It appears to be stable and in good condition. There is accumulation of debris in this channel which should be cleared.

4. Channel Immediately Downstream of Dam

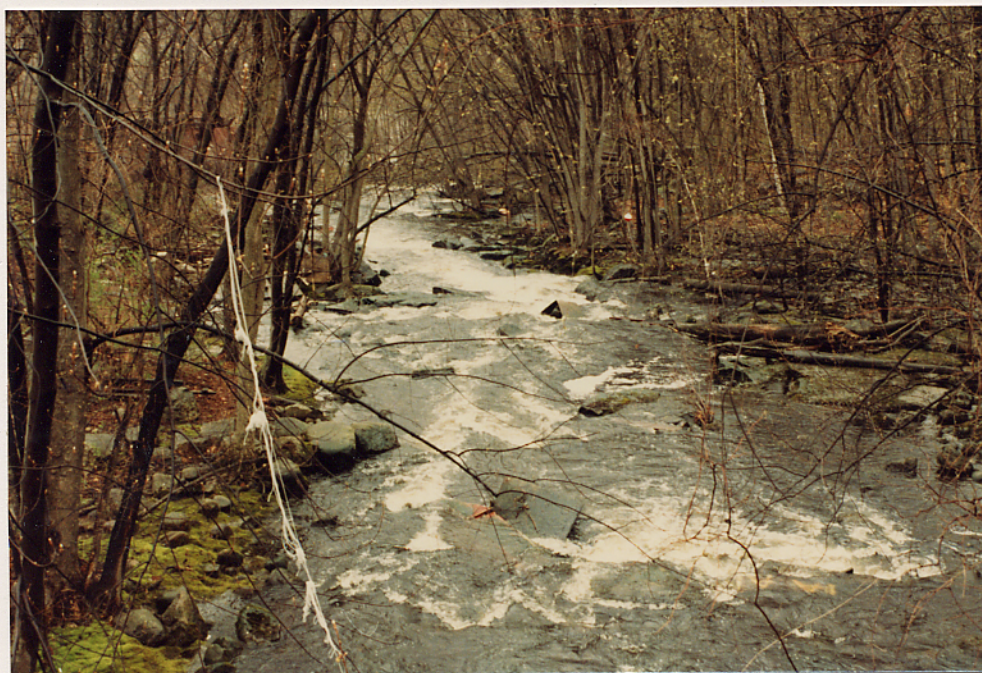
5. Channel Downstream of Highway Bridge
